Phase I Environmental Site Assessment Report

2510 SOUTH EAST AVENUE
FRESNO, CALIFORNIA 93775

RE: Phase I Environmental Site Assessment
2510 South East Ave.
Fresno CA 93775

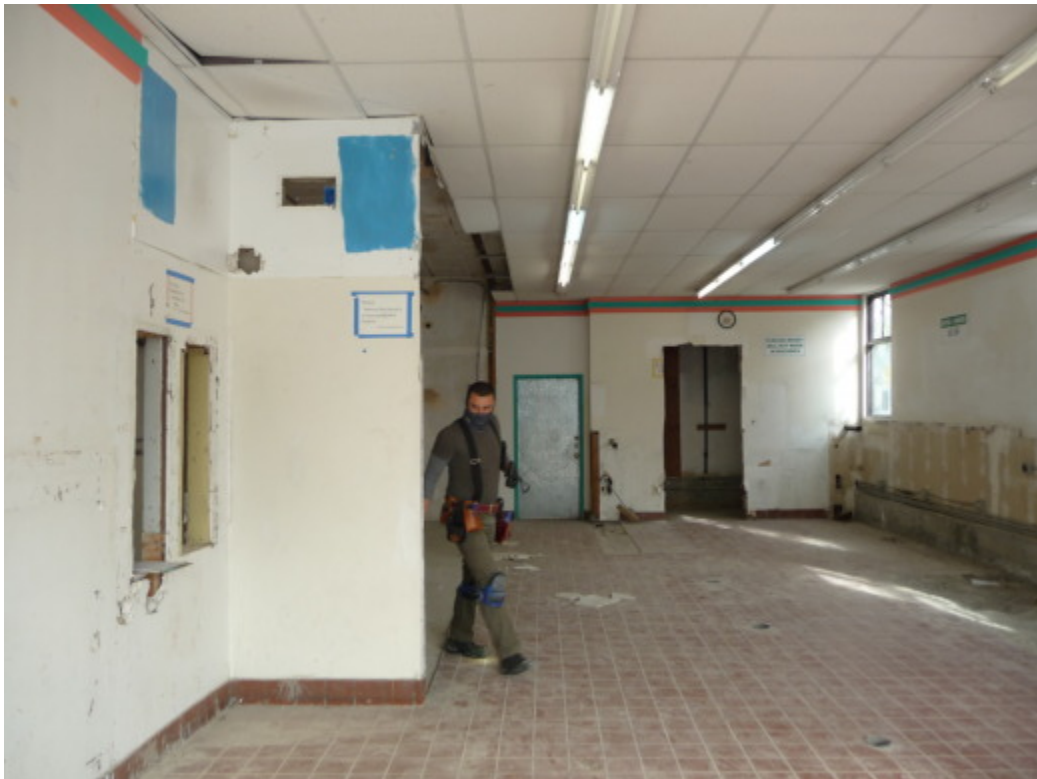
Floor drains and sumps were observed inside the building. No unusual staining or odors were observed at these locations. No clarifiers were observed.

PHOTO #6. VIEW INSIDE THE FORMER LAUNDRY.

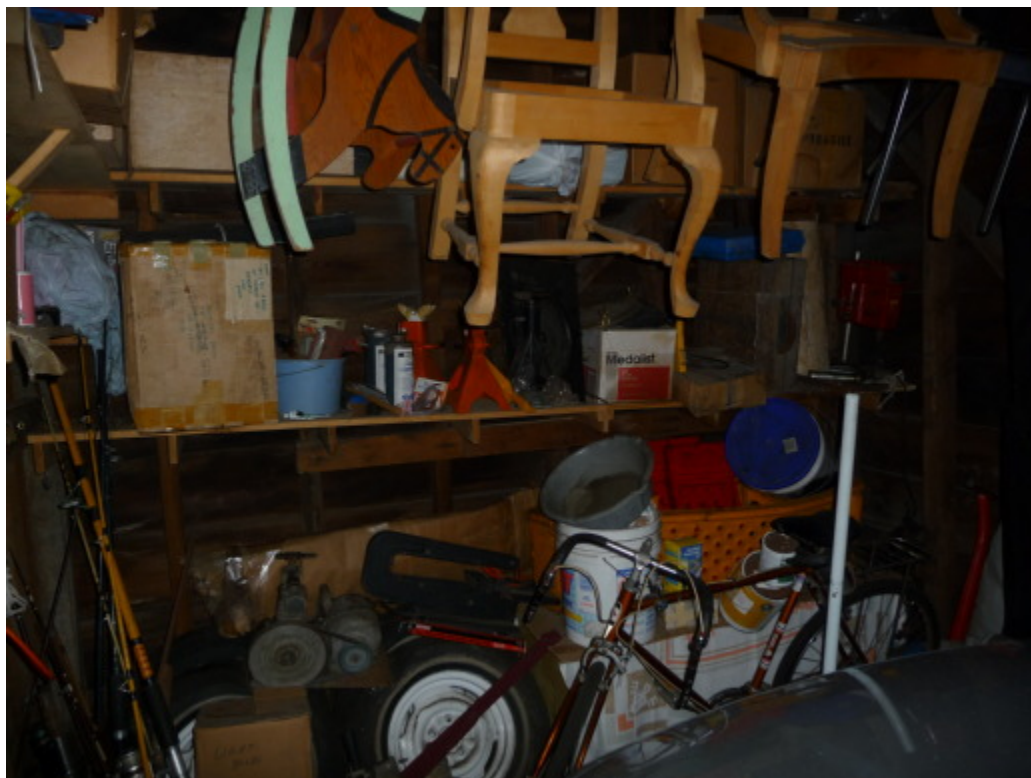
PHOTO #10. STORAGE INSIDE THE GARAGE.

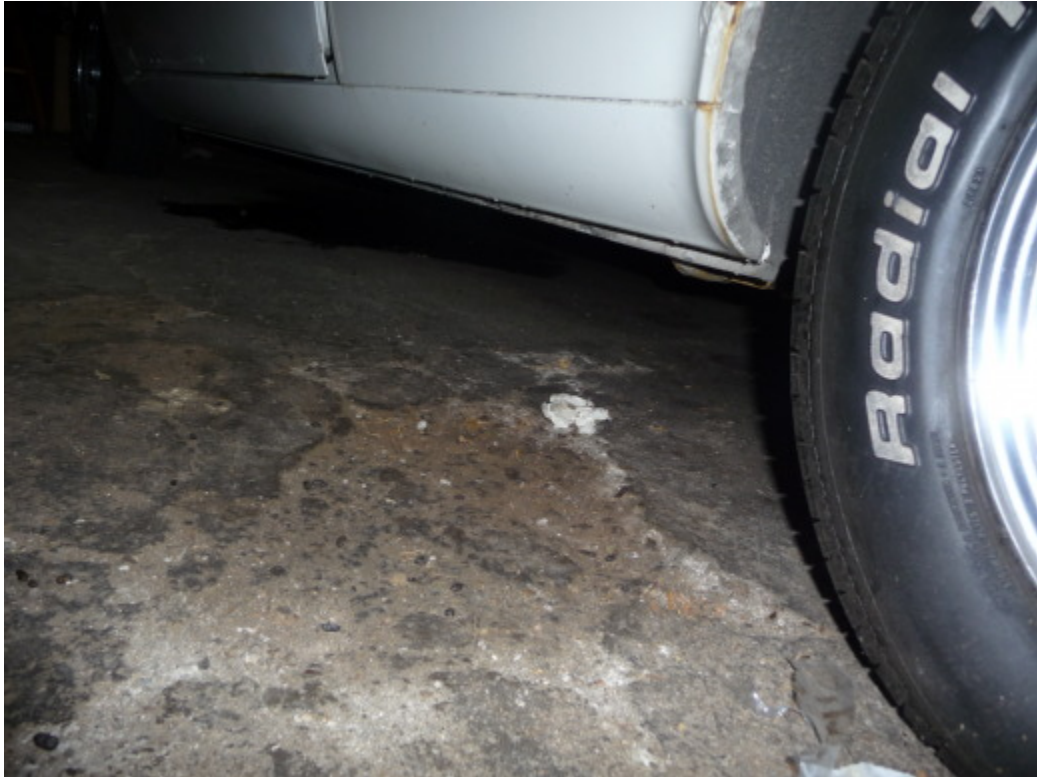
No stained soil was observed. No significant staining was observed on the exterior paved surfaces. Minor oil and grease was observed in places, but did not appear to be of significant environmental concern.

PHOTO #11. CONCRETE PAD BELOW A CAR IN THE GARAGE.

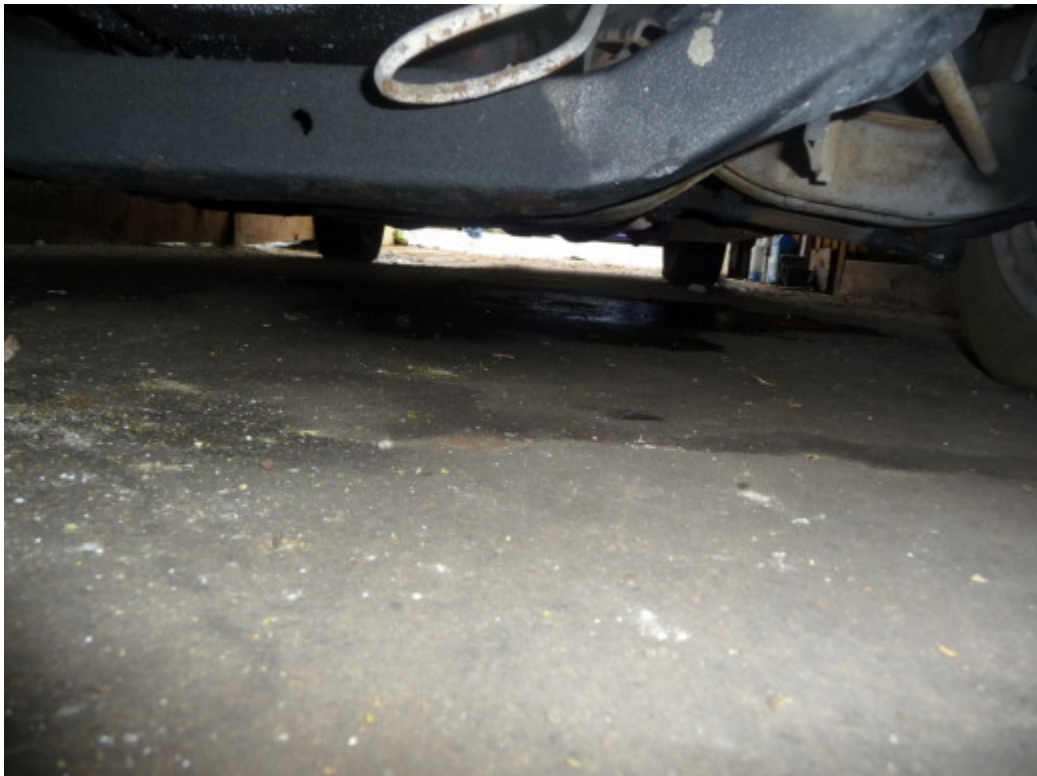
PHOTO #12. VIEW OF THE CONCRETE PAD IN GARAGE AREA.
